TITLE An Approach to Management of Critical Indoor Air Problems in School Buildings.

Environmental Health Perspectives, Volume 7, Supplement 3, June 1999

An Approach to Management of Critical Indoor Air Problems in School Buildings

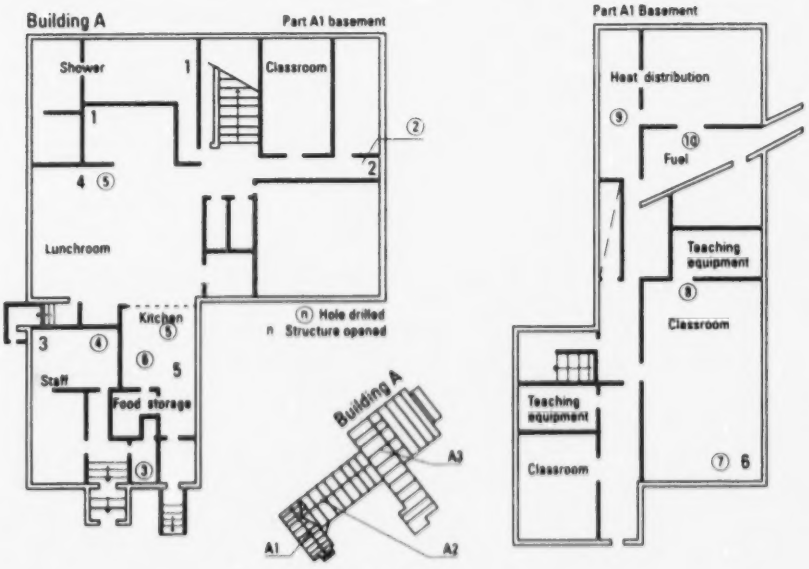
Figure 2. Site map of structural measures. See Table 1.

All available building documents, e.g., drawings, structural designs, and information about repair history of the buildings, were collected and the buildings were first examined visually (*3*). The most serious problems were registered in the base floors of the buildings. For on-site investigations, 20-mm holes were drilled throughout ground slab at 15 sites and through the wall structures at 2 sites (Figure 2). Building material layers and thickness were observed from cuttings and drill ability. If the drilling was successful, the holes were obstructed and the conditions were allowed to stabilize before moisture and temperature was measured. A bar was driven into the holes until the resistance became too great, to define soil type and moisture condition. To obtain more information, the structures were later opened (e.g., areas of approximately 0.2–1 m^2 were dismantled at 10 sites) (Figure 2). The ventilation in the

Drill hole number	Structure opening number	Relative humidty (%)	Room temperature (°C)	Temperature 1[a] (°C)	Temperature 2[a] (°C)	Type of the structure[a]	Microbial sample taken	Microbial growth recorded
–	1	–	–	–	–	2	Yes	Yes[b]
1	–	90	19	–	–	2	Yes	No
2	2	90	19	17	16[c]	1	Yes	No
3	–	88	19	15	–	1	Yes	No
4	3	[d]	–	–	–	1	Yes	Yes
5	4	88	19	20	–	2	No	–
6	5	80	19	–	–	2	Yes	No
6	–	20	–	–	1	Yes	Yes	
7	–	93	20	16	13[e]	1	No	–
8	–	94	20	19	17[c]	2	No	–
9	–	54	20	18	14[c]	2	No	–
10	–	94	20	19	16[c]	2	No	–

[a]According to Figure 3. [b]Microbial growth recorded under the topping slab. [c]Water does not flow below the ground slab. [d]Wood sample moisture content 12% by weight. [e]Water flows below the ground slab.

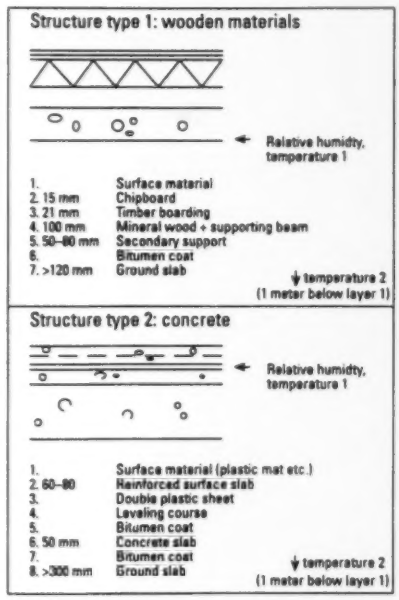
Various structure layers were observed from different sites in the stone school (A) and assumed to be results of earlier repairs. In general, structures could be categorized into two types: structures with layers of wooden materials and structures consisting mainly of concrete materials (Figure 3). Results from the structural measurements in the building are presented in Table 1. Moisture conditions in the site were problematic. The base floor was built mostly on a thick level of capillary clay, partly without

Figure 3. Examples of base floor structures in the stone school (A), categorized as wooden structures (type 1) and concrete structures (type 2). See Table 1.

capillary break. A groundwater monitoring tube showed that the groundwater was at the level of the concrete slab lower surface. Before the underdrain, rainwater sewer, and cellar walls outside the water barrier were built in the fall of 1995 as part of the repair process, surface water could seep under the building. Changes in this type of soil occur slowly, but it may also be impossible to stop the water penetration. All wooden structures (structure type 1) of the floor of the basement store had to be replaced by structures with better moisture resistance (*14*) and with surfaces through which possible moisture would evaporate.
